FIG. 255.—LOWER DAM, OR "PRESA DE LA OLLA," GUANAJUATO, MEXICO. VIEW TAKEN DURING THE FEAST DAY WHEN THE GATES ARE RAISED AND THE RESERVOIR EMPTIED.

The chapter on Masonry Dams has been increased twofold by an attempt to make some mention of all the most notable dams of the world, and many that are very little known. Attention is particularly directed to Plates 1, 2, and 3, in which profiles are shown of all of the leading and better known masonry dams in existence, drawn to uniform scale for easy graphical comparison. No such complete collection of dam profiles has ever before appeared in print, assembled together on a common basis.

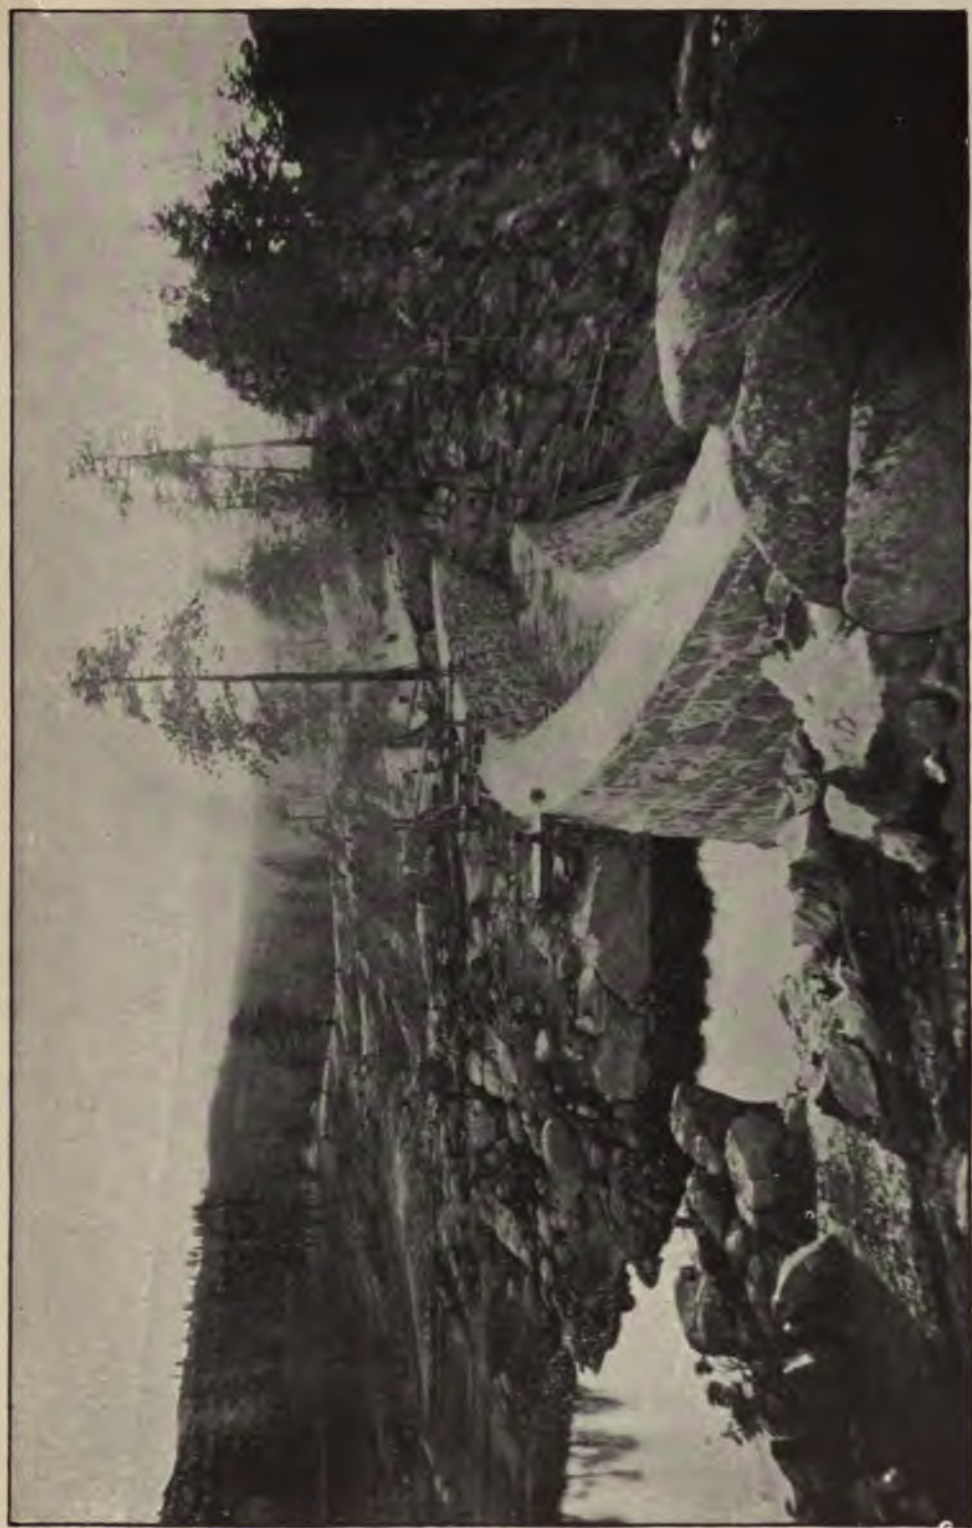
FIG. 167.—HEMET DAM AS FINISHED, SHOWING THE SPILLWAY RIDGE SOUTH OF THE DAM.

has thus far been erected in western America for irrigation-storage is the dam erected in the San Jacinto Mountains, in Riverside County, California, at the outlet of Hemet Valley, the location of which with respect to the irrigated lands is shown in Fig. 165. The view in Fig. 166 is rather an imperfect representation of the appearance of the dam from below. Fig. 167 is an end view which shows the arched form of the dam.

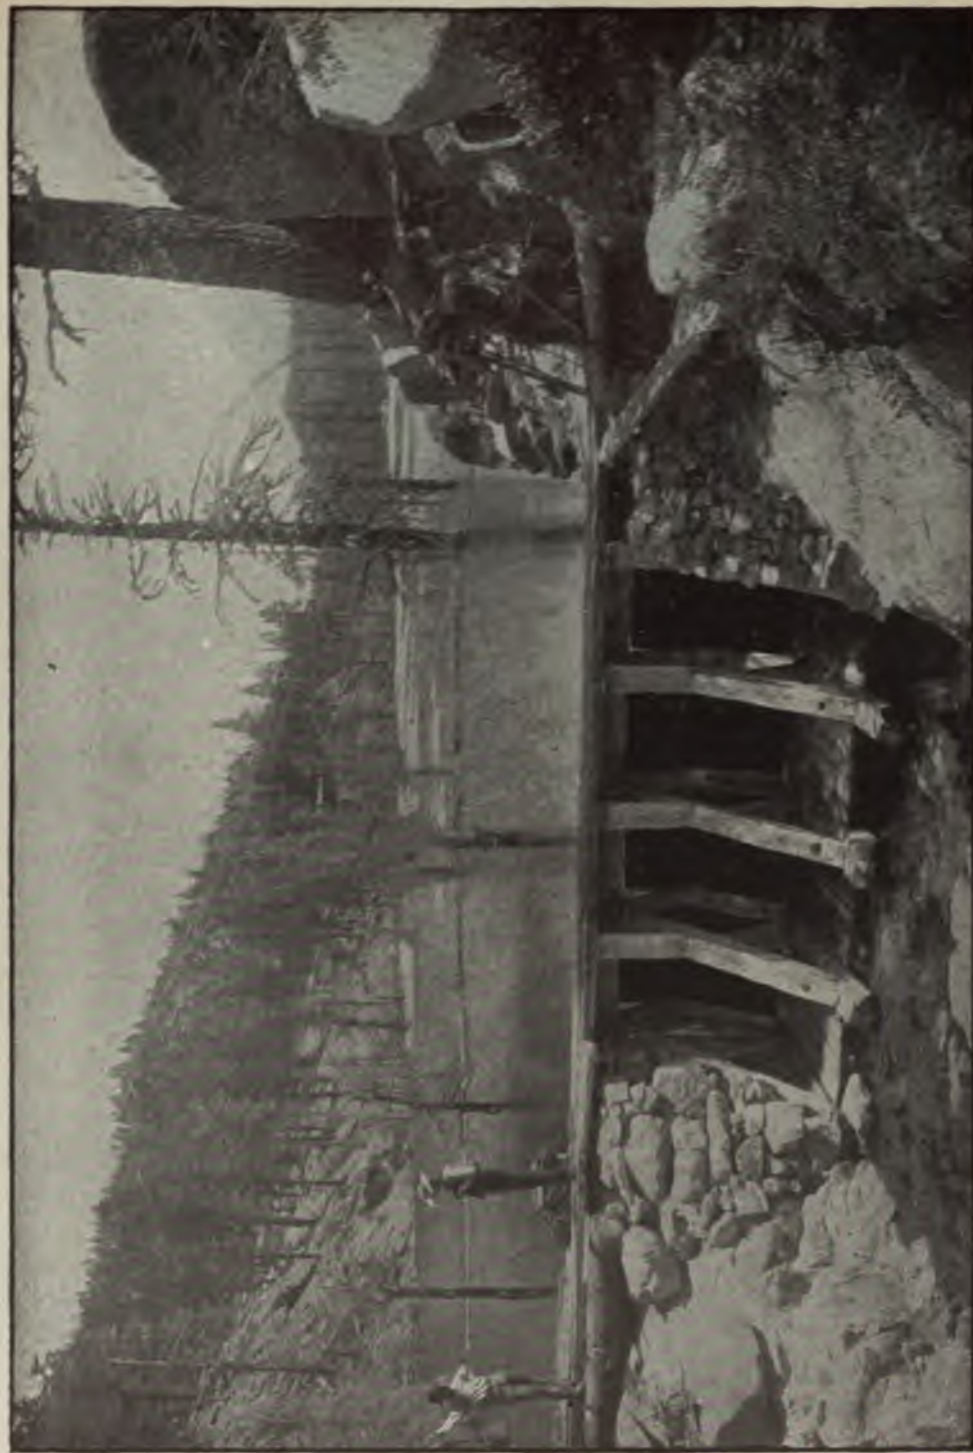
FIG. 175.—SPILLWAY OF BEAR VALLEY DAM, WITH FLASHBOARD GATES.

The south end of the dam abuts against a projecting ledge of granite, standing boldly out from the side of the canyon 100 feet or more beyond the general line of the side slopes, illustrated in the photograph, Fig. 170. Over the top of this ledge, as far from the dam as it could be placed, a spillway, 20 feet wide, was excavated to a depth of 8.5 feet below the level of the extreme top of the dam (Fig. 175).

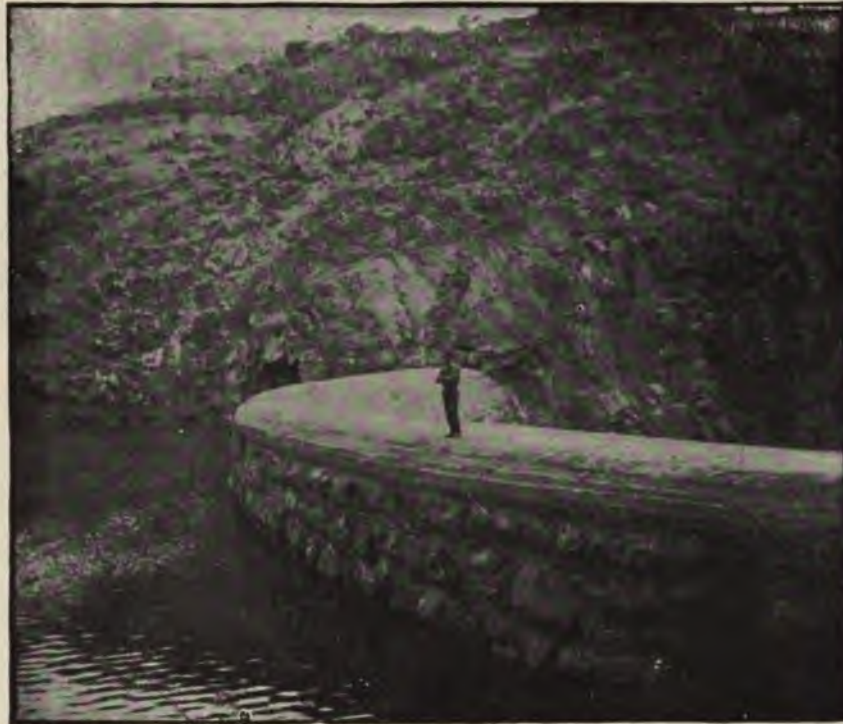
FIG. 180.—UPPER FACE OF LA GRANGE DAM.

The Modesto district covers 81,500 acres, with a main canal 22.75 miles long before reaching the district, having a capacity of 640 second-feet. The entire irrigation system when fully completed will be the largest and most comprehensive one in California, and the dam upon which its success depends has been wisely constructed of such dimensions as to be of unquestionable stability. Figs. 180 to 185 are views of the structure.

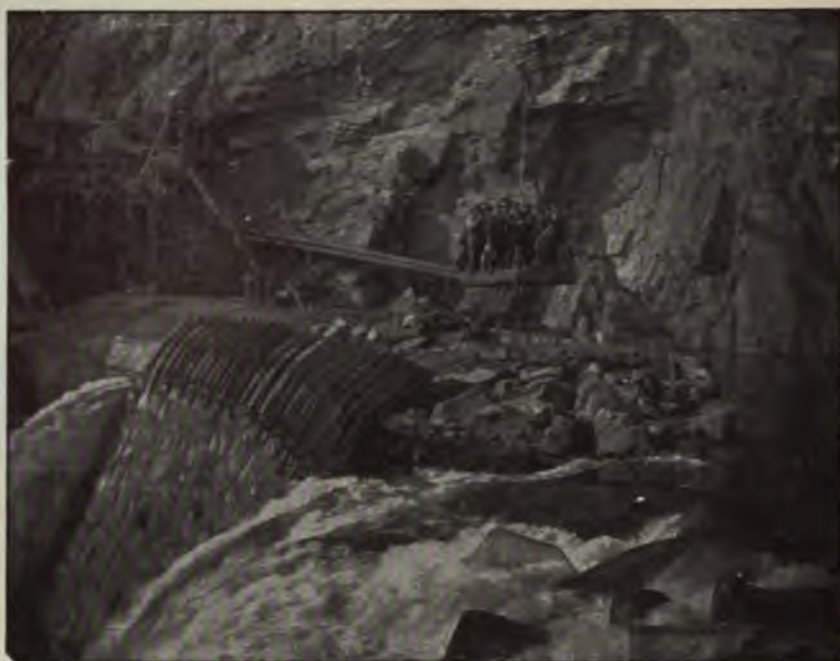
FIG. 181.—LA GRANGE DAM, CALIFORNIA, DURING CONSTRUCTION—FINISHING THE CREST.

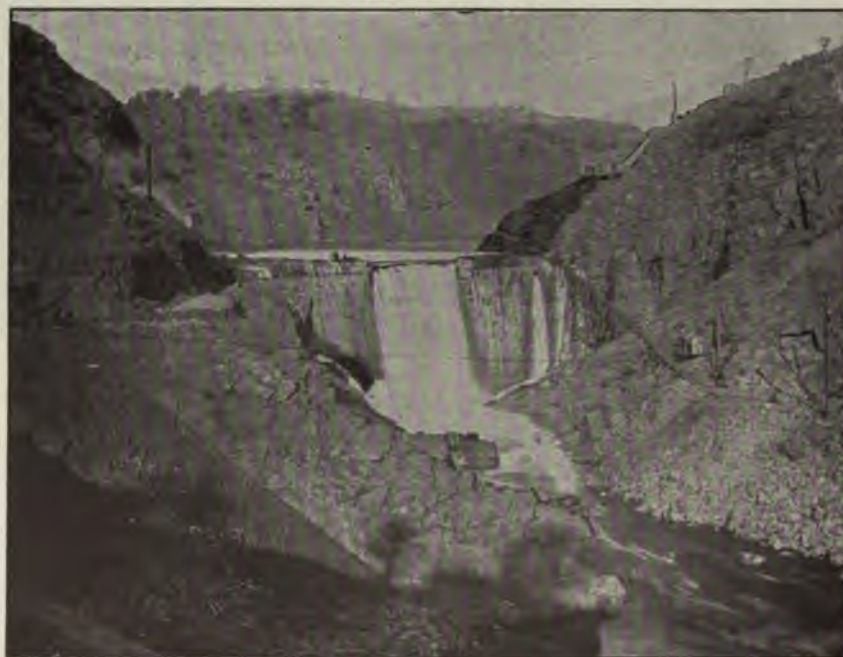
FIG. 182.—LA GRANGE DAM, CALIFORNIA.

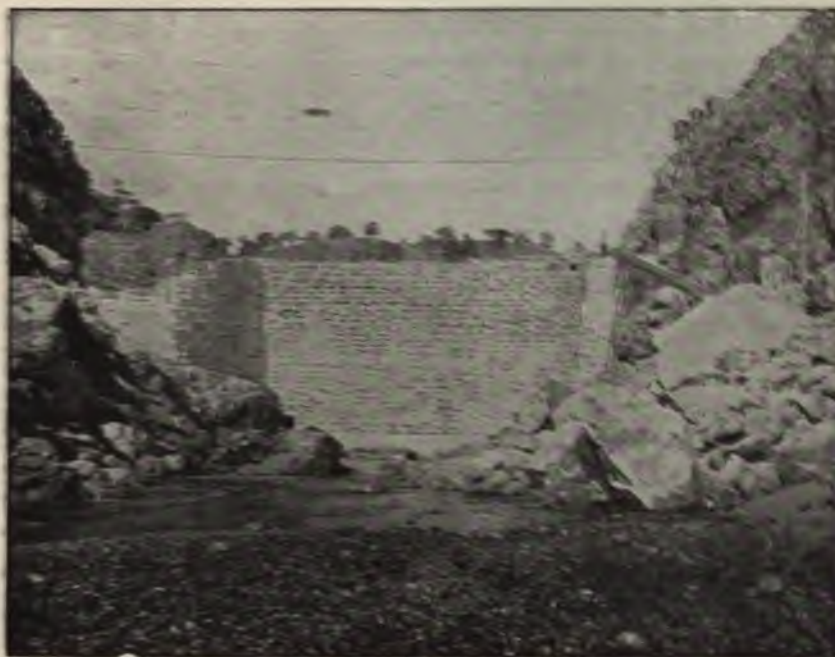
FIG. 183.—LA GRANGE DAM, CALIFORNIA

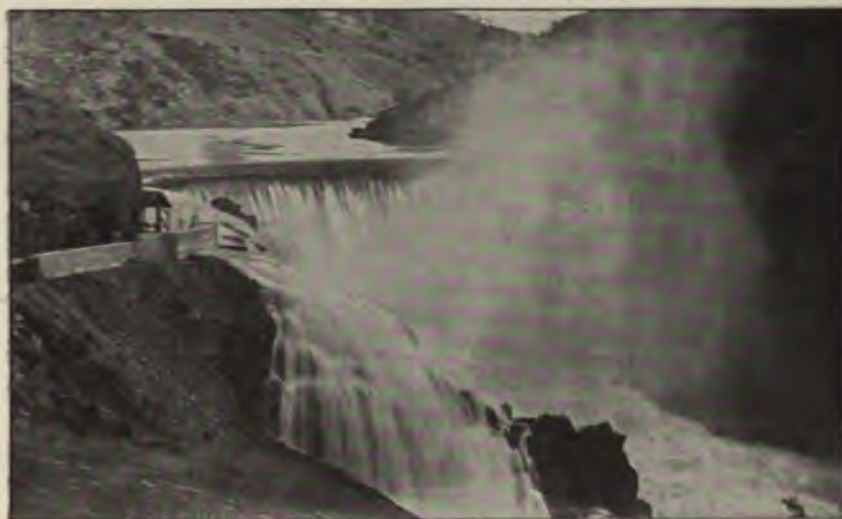
FIG. 184.—LA GRANGE DAM, CALIFORNIA, DURING FLOOD.

It is believed to be the highest overflow dam in the United States, if not in the world. The volume of water passing over it may in extreme floods amount to 100,000 second-feet. The maximum flood that has yet gone over the dam was about 46,000 second-feet in volume, the depth on crest being 12 feet.

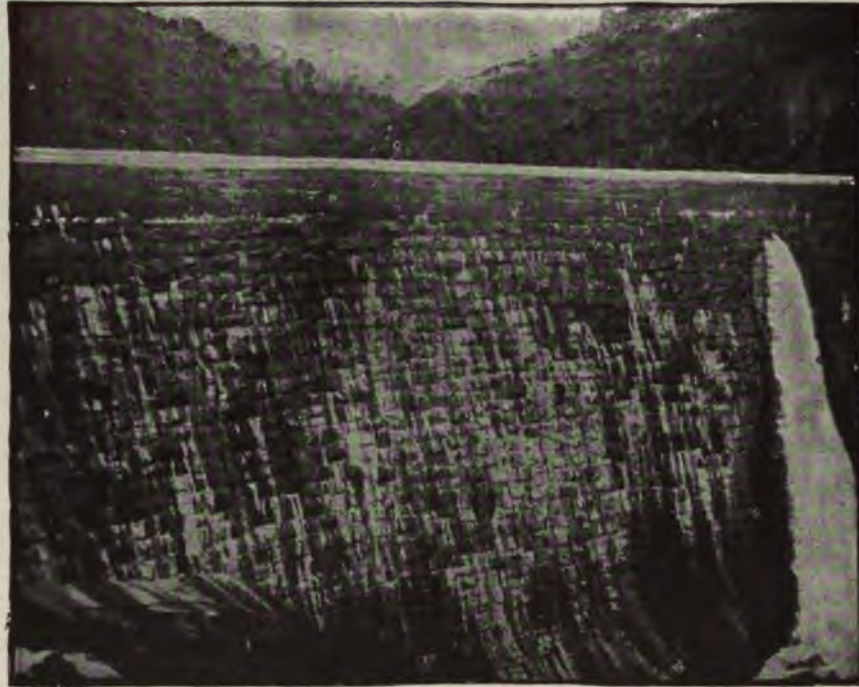
FIG. 185.—LOWER FACE OF LA GRANGE DAM.

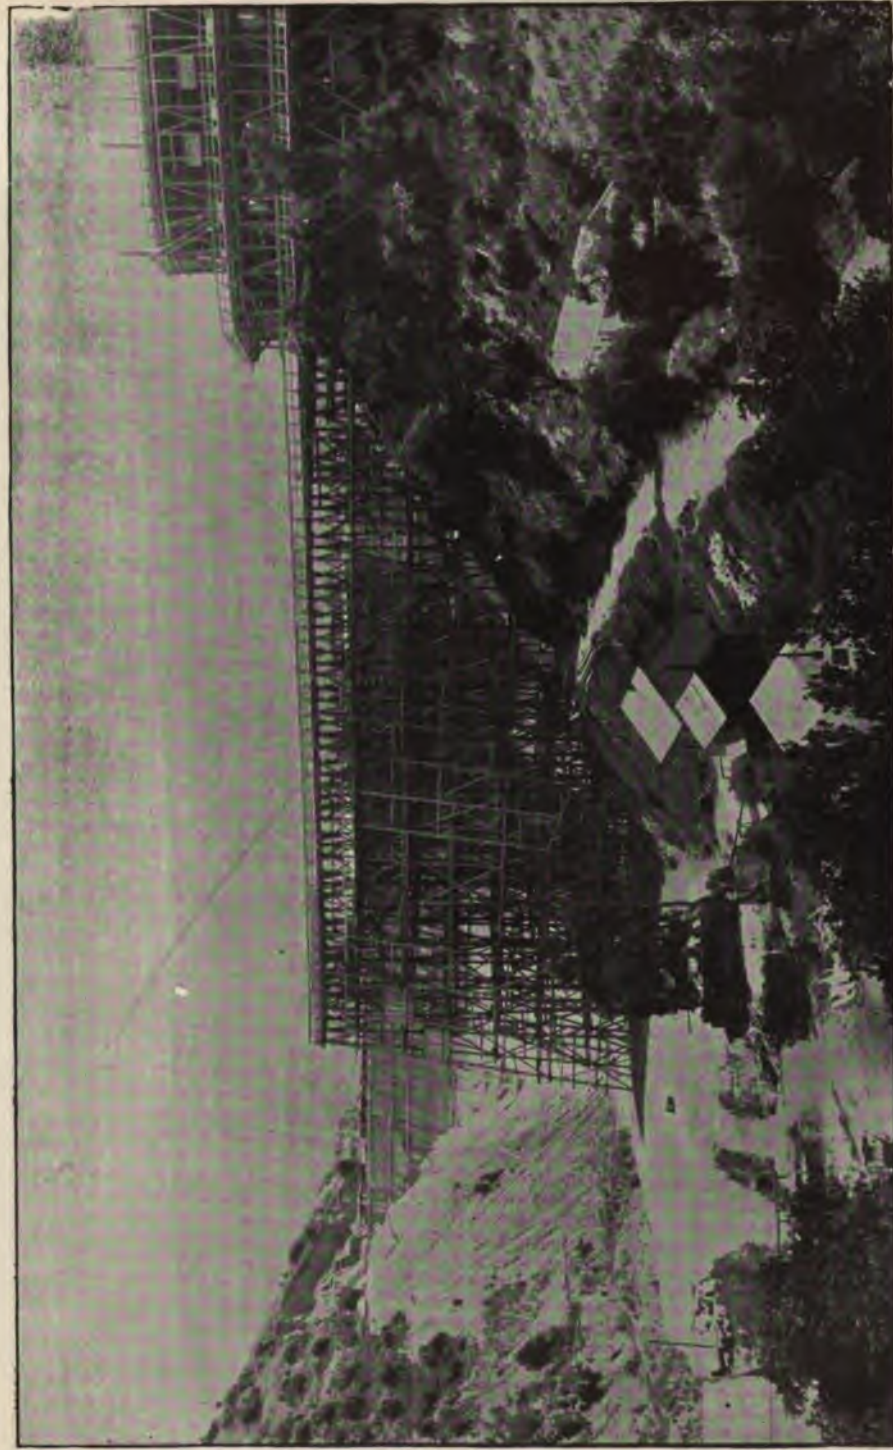
FIG. 190.—PLANT FOR MIXING AND HANDLING CONCRETE AT SAN MATEO DAM.

The concrete was mixed in a battery of 6 cubical iron mixing-machines revolved by steam-power. It was delivered to the work by a double-track tramway on a high trestle carried part way across the canyon at the level of the top of the dam on the lower side, as shown in Fig. 190. The cars on this tramway were pushed by hand and dumped into hoppers let into the floor between the rails, leading to vertical pipes, 16 inches in diameter, which extended down to platforms that were placed from time to time at a level with the top of the work as it progressed. The concrete dropped down these pipes, striking on steel plates, from which it was shoveled into wheelbarrows and trundled to the place of use. The height of this drop was sometimes as great as 120 feet, but no injury resulted to the concrete, or to the men shoveling it as it fell. The concrete was mixed in the proportions of 1 part cement to 2 parts sand, $6\frac{1}{2}$ parts broken stone, and $\frac{3}{4}$ part water by measure. It was moulded in cyclopean blocks of 200 to 300 cubic yards each, with numerous offsets ingeniously dovetailing the blocks together, and every possible precaution was taken in the joining of the successive portions to secure an absolute bond. The surfaces of the blocks after the forms were removed were roughened with picks, swept and washed clean, and grouted with pure cement before concrete was placed against them. The result has been very satisfactory; the dam is almost absolutely water-tight, although some moisture does find its way through and appears in spots on the lower face. No settlement or expansion cracks are visible, and the work has the appearance of being absolutely homogeneous. Figs. 192 and 193 show the general method of forming the blocks and preparing them to receive fresh concrete, and Fig. 194 is a general view of the dam taken at the time of the visit of the American Society of Civil Engineers in Annual Convention, July, 1896. Plans and sections of this dam are shown in Fig. 191. At the 170-foot level the reservoir will have a capacity of 29,000,000,000 gallons, or 89,000 acre-feet. The present capacity is approximately 20,000,000,000 gallons.

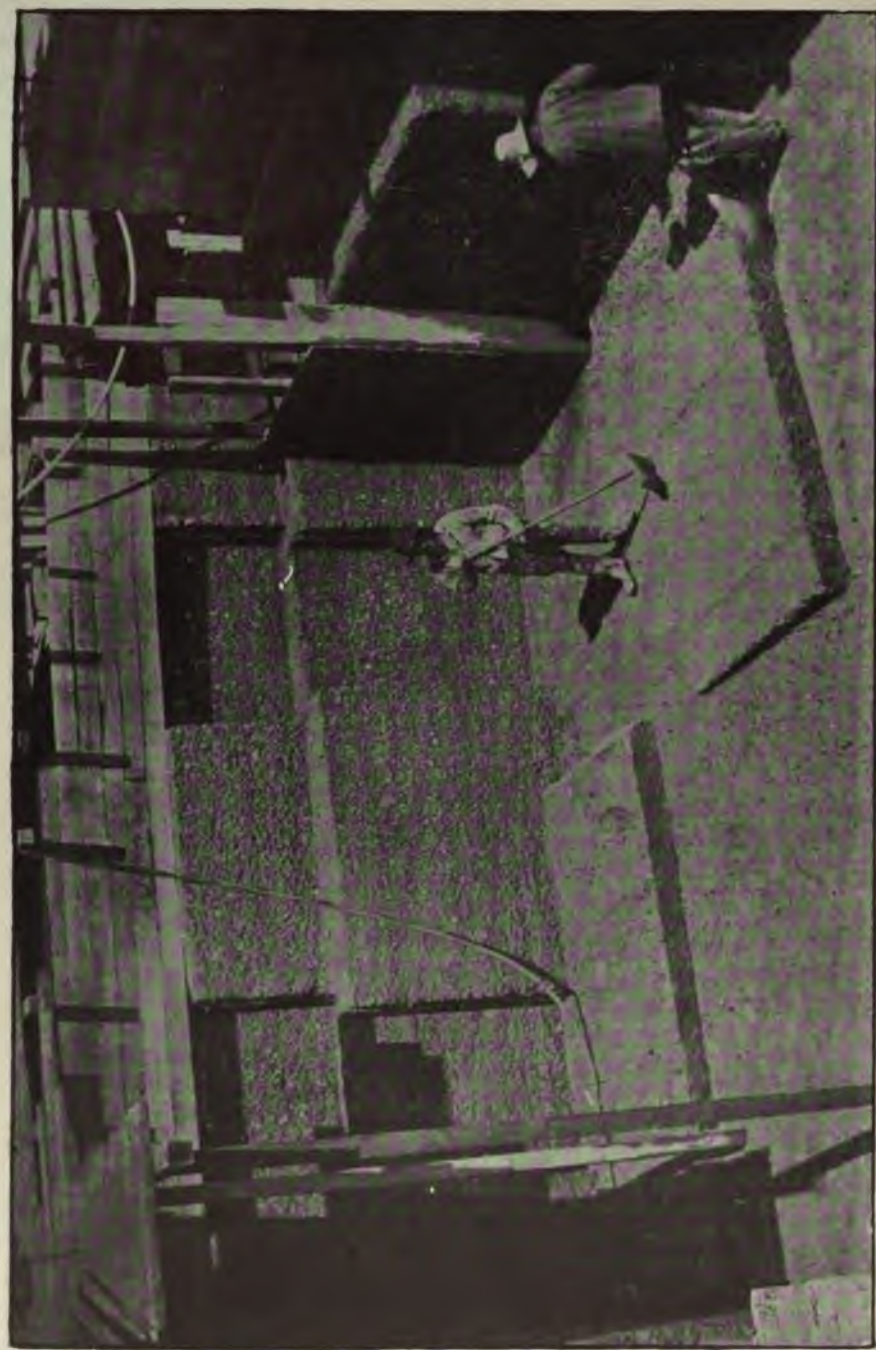
FIG 193.—ROUGHENING SURFACE OF CONCRETE BLOCKS TO RECEIVE FRESH CEMENT, AT SAN MATEO DAM.

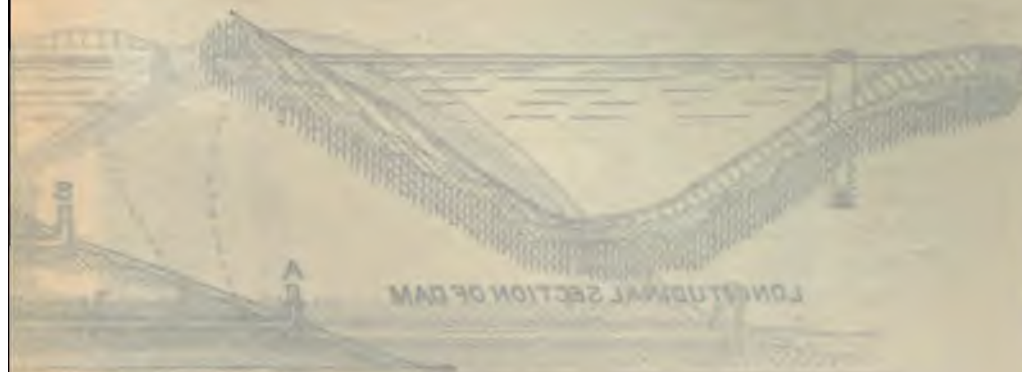
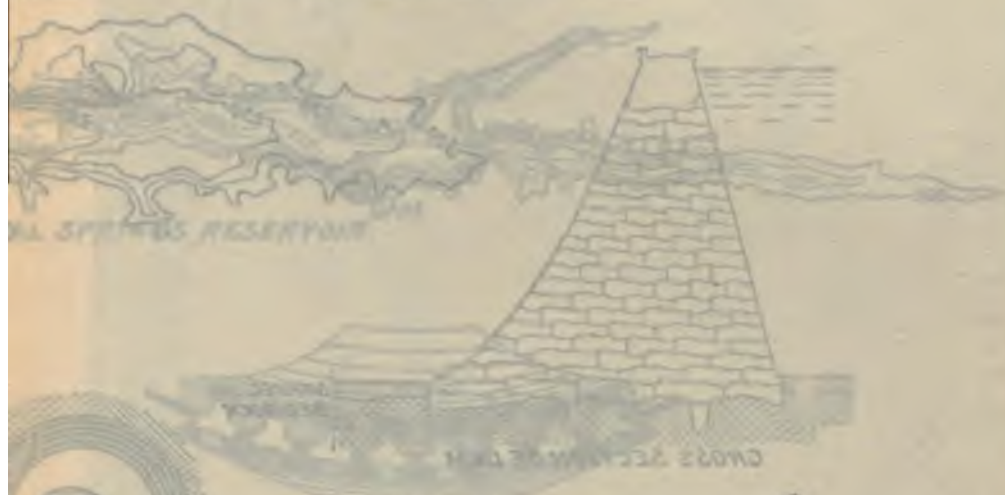
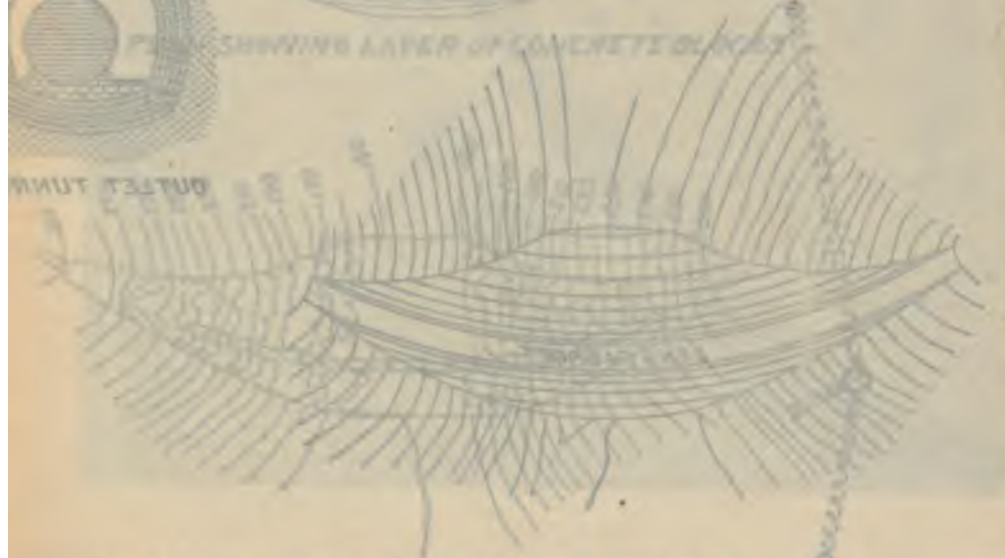
LONGITUDINAL SECTION OF DAM

SECTION GATEWAY AND OUTLET TUNNEL

CROSS SECTION OF DAM

PLAN SHOWING LAYER OF CONCRETE BLOCKS

OUTLET TUNNEL

ROCK EXCAVATION FOR FOUNDATION ON DAM

close a gap in the ridge a short distance north with a wall about 25 feet high. The outlet to the dam is a tunnel 390 feet long, driven through the hill on the north side of the channel, through which a 54-inch riveted iron pipe is laid. The tunnel is $7\frac{1}{2}$ feet wide inside the lining, and of the same height, and is lined with four courses of brick, 21 inches thick.

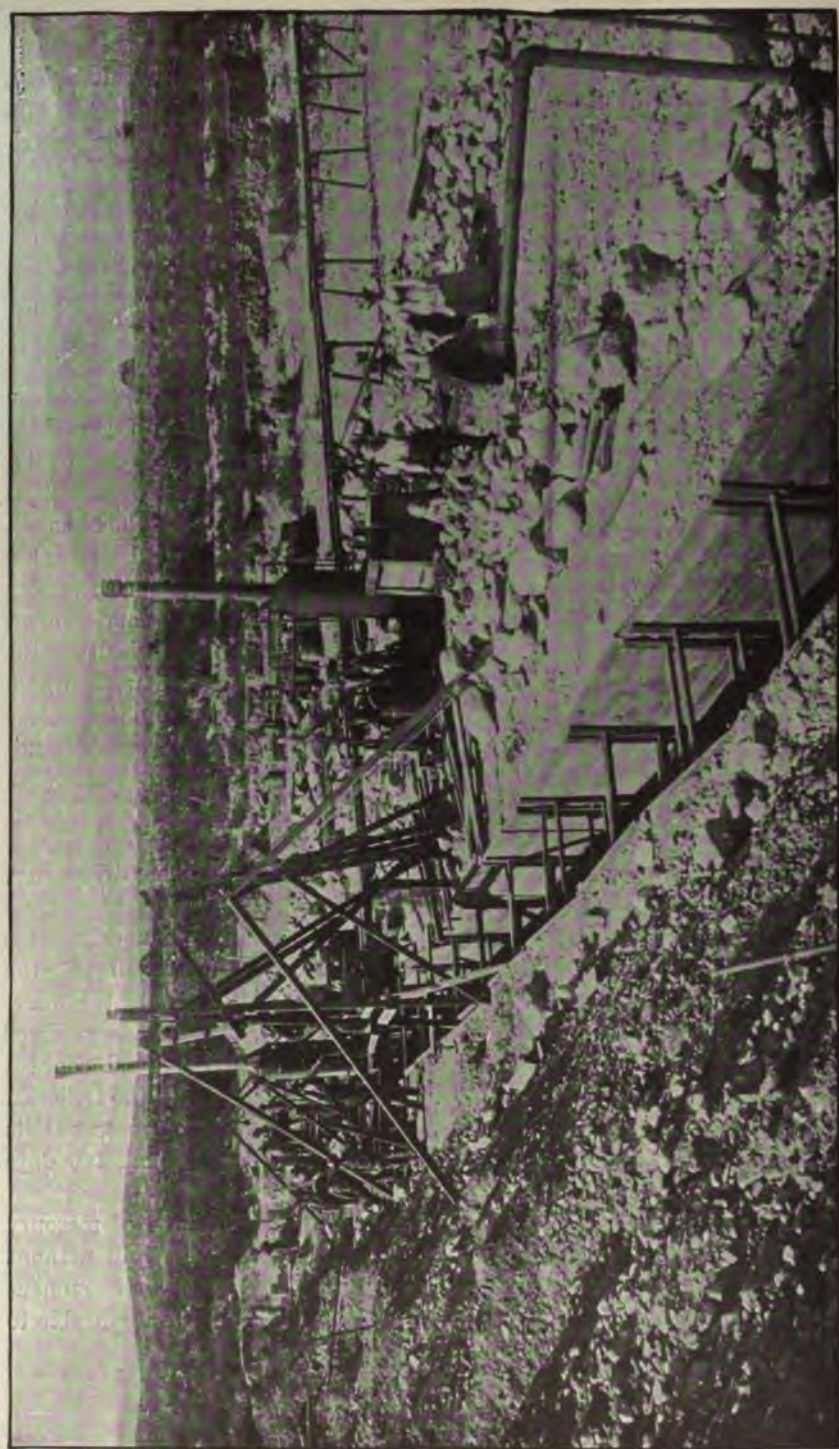
FIG. 196.—EXCAVATION OF TRENCH FOR PACOIMA SUBTERRANEAN DAM.

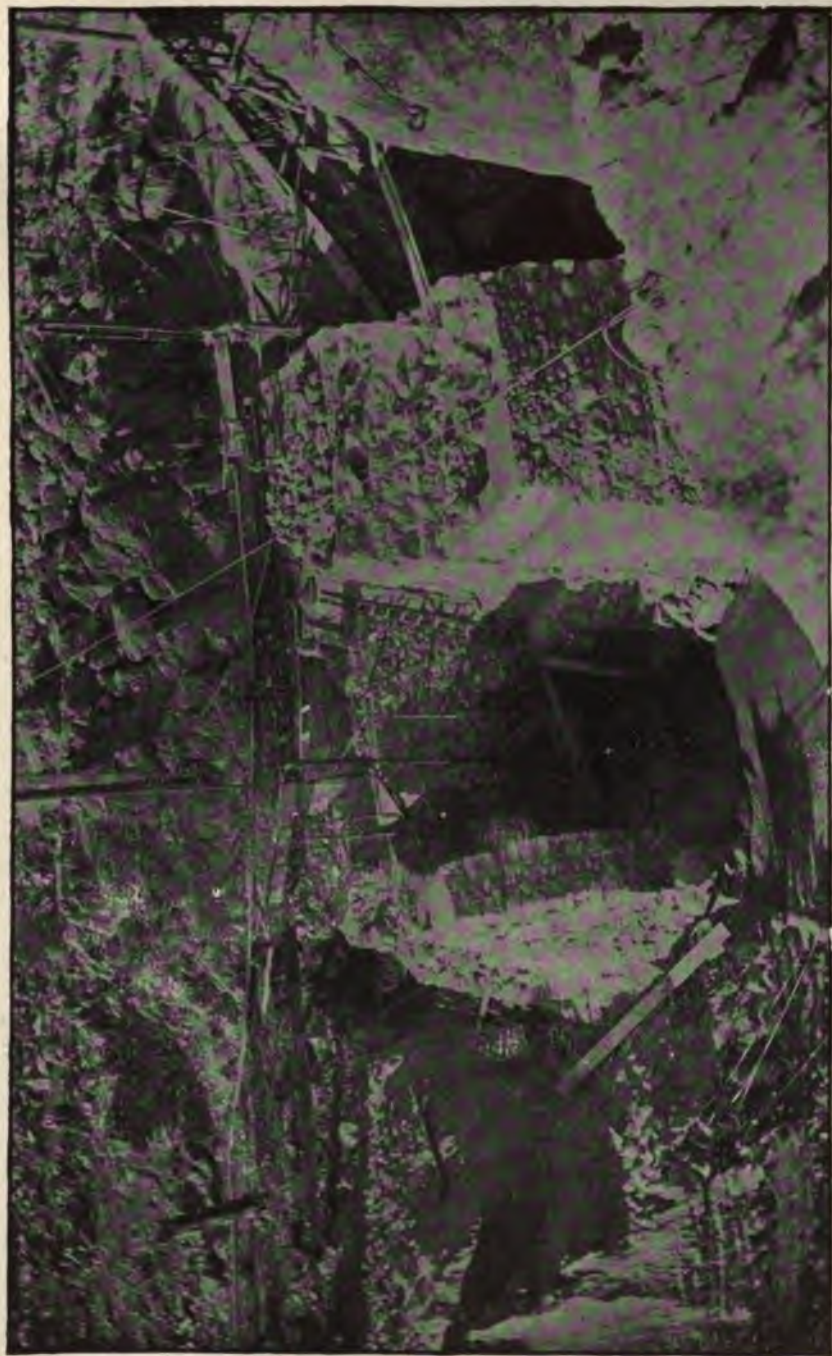
FIG. 200.—FOUNDATIONS OF WEST CHANNEL OF AGUA FRIA DIVERTING-DAM.

The masonry used in the diverting-dam is a rough rubble, faced with coursed ashlar, mostly laid in a mortar of hydraulic lime of good quality, burned about 20 miles from the dam. (See Figs. 200 and 202.) For a portion of the work a small amount of Portland cement, made in Colton, California, was used. The rock was handled by a Lidgerwood cableway, with a span of 700 feet. The excavation of foundations, amounting to about 12,000 cubic yards, was accomplished by teams and scrapers, the water being handled by centrifugal pumps.

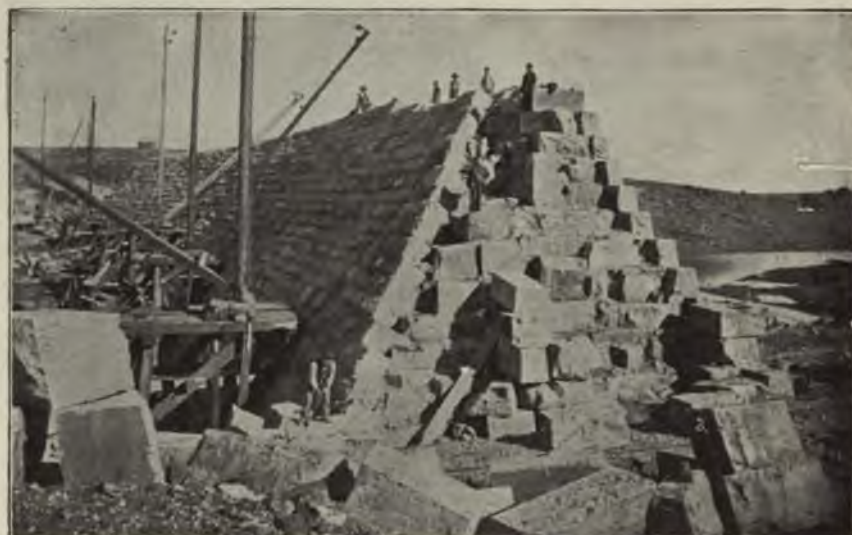
FIG. 204.—SELIGMAN DAM, ARIZONA.

The character of the masonry is well shown by the photograph (Fig. 204) of the lower face during erection. Fig. 205 shows the water-face and end buttresses. The water appearing in the foreground is retained by a low earth dam that had been in use for some time prior to the construction of the masonry dam. The center of the dam is depressed two feet below

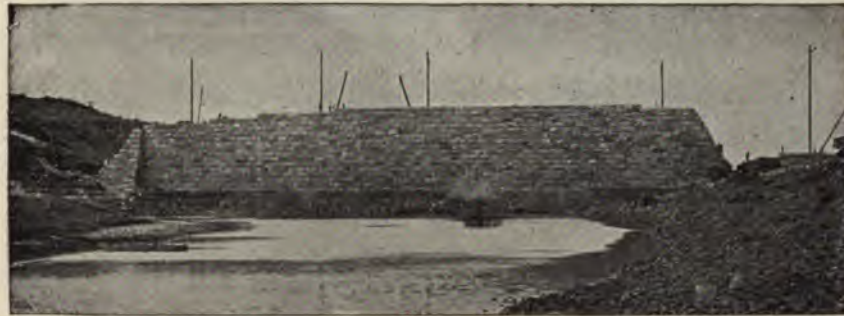
FIG. 205.—SELIGMAN DAM, ARIZONA. VIEW OF UPPER FACE DURING CONSTRUCTION.

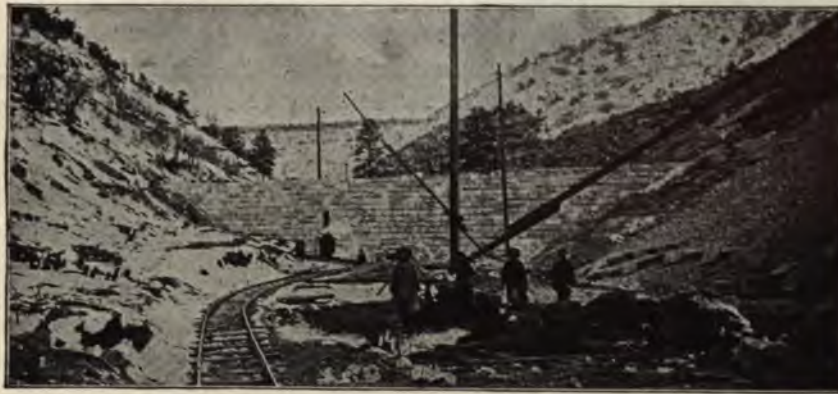
FIG. 207.—WALNUT CANYON DAM, ARIZONA.

Fig. 207 is a view of the dam from below when nearly completed. Fig. 208 shows the profile of the dam as constructed, and a section of the canyon at the dam-site.

The Walnut Canyon Dam.—Walnut Canyon is a tributary of the Little Colorado River, which heads in Mormon Mt. a little south and east of Flagstaff. The watershed area above the dam is 126 square miles, which ordinarily affords a much greater run-off than the storage capacity of the reservoir. The geological formation of the canyon walls at the dam-site is sandstone in heavy layers or strata in nearly level beds. The bottom of the canyon was so filled with debris of earth and stone that it was necessary to excavate 28 feet below the surface to reach bed-rock, on which the dam was erected. The width at this point was but 30 feet, at the surface of stream-bed 120 feet, and at the top of the dam 268 feet. The extreme height of the dam is 77.6 feet. Its thickness at base is 61.5 feet. The water-face is vertical, while the upper face has a batter of $7\frac{1}{2}$ inches to the foot between the vertical curves at top and toe. The top is rounded in parabolic form to a thickness of 13 feet at a point 10.4 feet below the crest, to form an easy overflow for surplus waste water, while at the base the wall is vertical for 10 feet, above which is a vertical curve, tangential to the horizon, passing through 58° of arc, to a point 46.4 feet below the top, where the thickness is 35.5 feet. This design forms an exceedingly massive structure with unusually large factor of safety. The dam is arched up-stream with a radius

of 400 feet to the line of the water-face. The masonry consists of 5244 cubic yards of heart rubble, 1572 cubic yards of facing ashlar masonry in irregular courses, with dressed beds, and 80 cubic yards of cut coping-

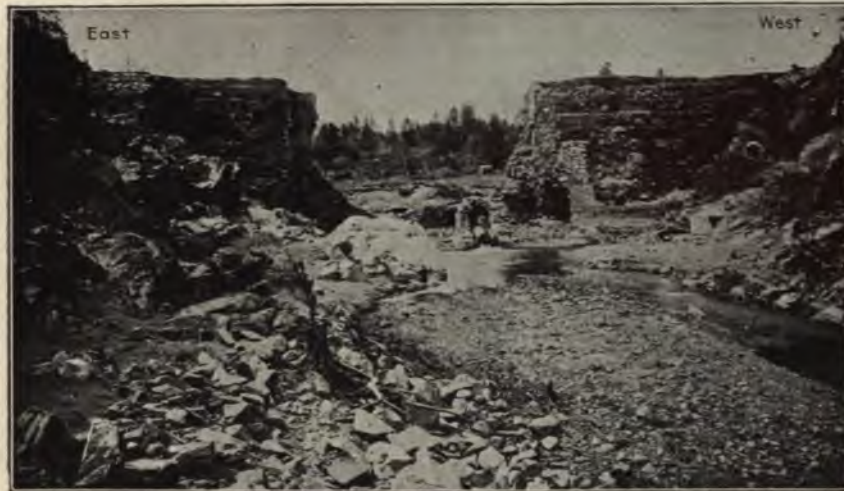
FIG. 209.—LYNX CREEK DAM, ARIZONA, AFTER RUPTURE BY FLOOD. VIEW FROM BELOW.

Lynx Creek Dam, Arizona.—This structure was located 12 miles east of Prescott, Arizona, and was designed to impound water for hydraulic mining on Lynx Creek, some 4 miles below. It was intended for an ultimate height of 50 feet, and was started with a base of 28 feet. When it had reached a height of 28 feet on the up-stream side, the lower edge of the crest being 2 feet higher, it was roughly squared off with the intention of adding the remaining portion at a later date, when a sudden flood overtopped the dam and ruptured it, taking out about 35 feet of the masonry down to the bed-rock. The break is shown by the view, Fig. 209, looking up-stream. It occurred in 1891, and the dam has never been rebuilt. The dimensions of the dam were ample to withstand any overflow to be expected from the

floods draining the tributary watershed of 30 square miles of territory, from 5500 to 7500 feet in elevation, had the masonry been of reasonably good quality. The failure, therefore, was clearly due to poor workmanship and unsuitable materials. The dam was 150 feet long on crest, and was built with a central angle of about 165° opposed to the direction of the current, the up-stream face being vertical. The wall consisted of a thin facing of hand-laid masonry, not over one foot thick, the core being filled with a weak concrete of fine gravel, stone, spawls, and sand. The section of the dam as constructed is clearly seen from the photograph (Fig. 210). Considerable lime was used with the cement, which was of poor quality, and the concrete, though ten years old, possesses so little cohesion that it may be crumbled with a light touch. The cement used averaged but 1 barrel to 6 cubic yards of masonry. The failure of the dam, under all the circumstances, might have been anticipated. It is referred to here merely as an example to illustrate the natural consequences that must follow any carelessness or lack of attention to proper selection of materials and skill of construction in masonry or concrete dams that must withstand the erosive action of floods as well as normal water-pressure.

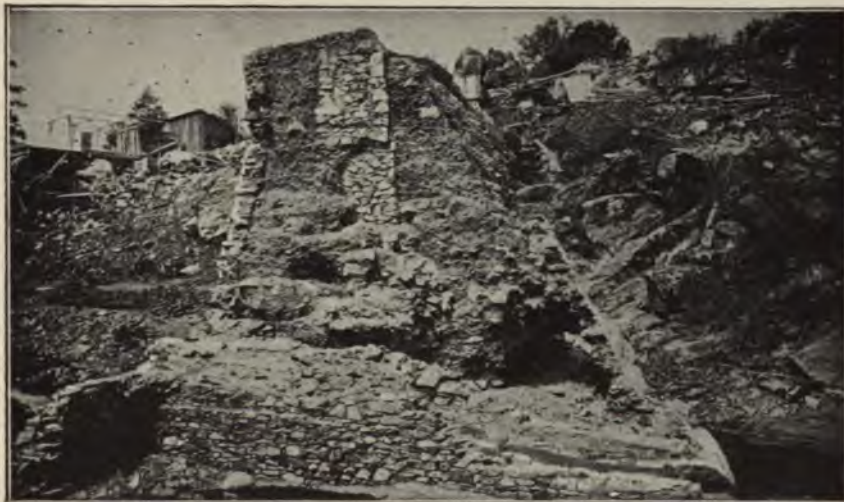
FIG. 210—LYNX CREEK DAM, ARIZONA. SECTION SHOWING FACING WALLS AND CONCRETE HEARTING.

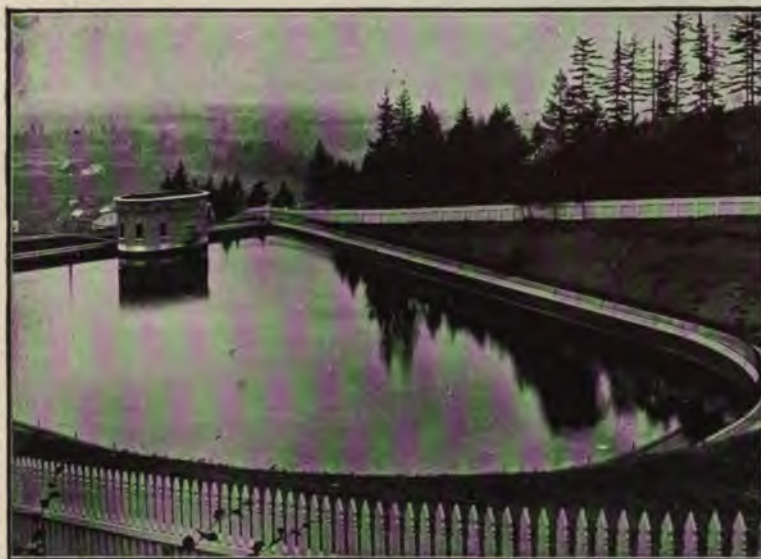
FIG. 211.—RESERVOIR NO. 1, PORTLAND, ORE., WATERWORKS. CONCRETE DAM WITH EARTH BACKING.

Concrete Dams of Portland, Oregon.—Among recent constructions of concrete masonry three dams designed and erected by the author for the water-works of Portland, Oregon, in 1894, may be classed as worthy of note. They were built for the purpose of forming distributing reservoirs, and were located across natural ravines, or embayments in the hills, the reservoir space being largely augmented by excavation, and the slopes covered with a lining of concrete. One of these dams, shown in Fig. 211, closes reservoir No. 1 on the side of Mount Tabor, and is 35 feet high, 300 feet long, with a base of 18 feet and top width of 6 feet. The reservoir capacity is 12,000,000 gallons. Behind the dam the material excavated from the reservoir was placed, forming a heavy embankment whose top width is 100 feet. This is such an immovable barrier that the chief function of the concrete wall is to act as a retaining-wall for the inner slope of the earth-fill, and to form a part of the reservoir lining. The reservoir receives the water delivered by a steel-pipe line 24 miles long, amounting at maximum capacity to 22,400,000 gallons daily, and distributes it to three other reservoirs, one of which is but 2000 feet distant, shown in the photograph Fig. 216, and the other two are five miles away, across the Willamette River, and designated as reservoirs 3 and 4 (Fig. 213). Reservoir No. 3, high service, has a dam 200 feet long which is arched up-stream with a radius of 300 feet. Its height is 60 feet, base 40 feet, top width 15.5 feet, carrying on its crest a driveway of the City Park, in which it is located. This is the only dam of the three which is curved, and the only one which does not exhibit some slight expansion-cracks. The dam forming reservoir No. 4, low service, is 50 feet high, 350 feet long, and 40 feet wide at base. The faces of these two dams, both of which are in the

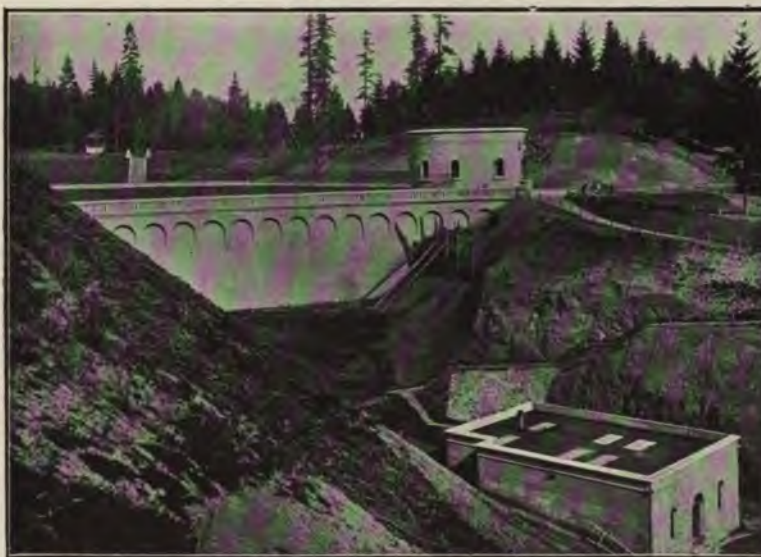
FIG. 212.—CONCRETE DAM, 60 FEET HIGH, AT RESERVOIR NO. 3, PORTLAND, ORE. POWER-HOUSE IN FOREGROUND.

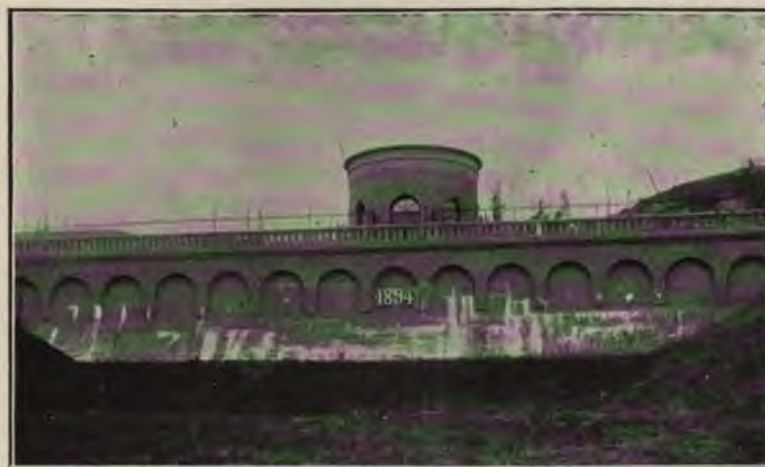
FIG. 215.—CONCRETE DAM OF RESERVOIR NO. 4, PORTLAND, OREGON., WATERWORKS.

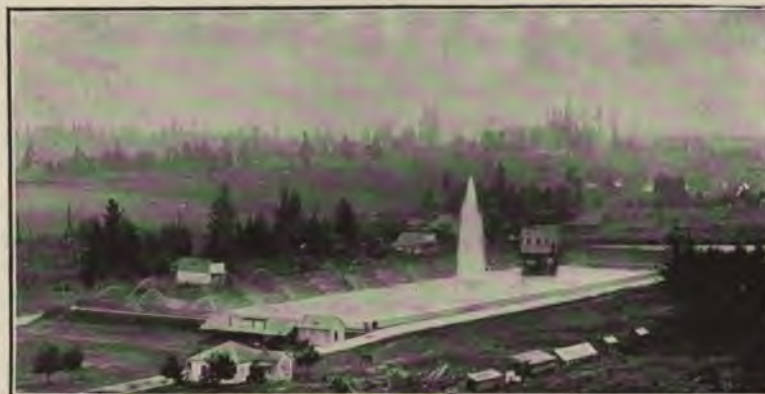
FIG. 216.—RESERVOIR NO. 2, PORTLAND, OREGON, WATERWORKS, SHOWING AERATION FOUNTAINS.

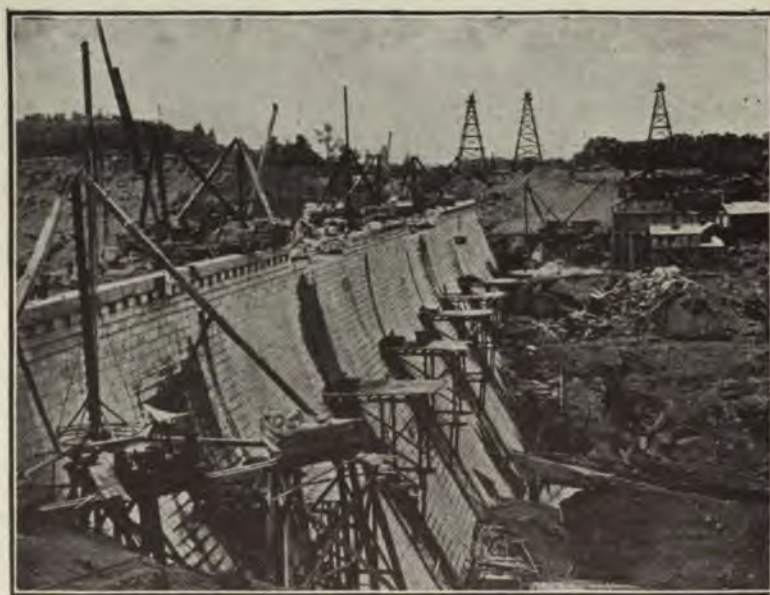
FIG. 220.—THE CROSS RIVER DAM FOR NEW YORK CITY WATER SUPPLY.

The Cross River Dam, New York (Figs. 219 and 220).—The Aqueduct Commission of New York City have under construction and practically completed a high masonry dam for storage of water on Cross River, a branch of the Croton River, near Katonah, N. Y., to the extent of a total capacity of 9,000,000,000 gallons (27,540 acre-feet) at a cost under the contract awarded to MacArthur Bros. Company and Winston & Co. of \$1,246,211.60.

The dam will have a maximum height of 170 feet above the foundation, and a crest length of 772 feet. The width on top is 23 feet, and at base 127.7 feet. The total volume of the masonry is computed at 155,000 cubic yards. It consists of cyclopean rubble, laid between facing walls of concrete blocks, 2 to 3 feet wide, 3 feet in depth at bottom courses, diminishing to 2 feet at the top. The concrete of those blocks is mixed in the proportions of 1 of cement, 2.3 sand, and 4.7 broken stone, moulded in steel-faced moulds to produce a smooth surface. These blocks are set in rich mortar, consisting of 1 of cement to 2.5 of sand and pointed with 1:1 mortar. The blocks have a maximum weight of 6 tons. The concrete of the heart of the dam is mixed in the proportion of 1:3.2:5.8 into which large blocks of stone are imbedded.

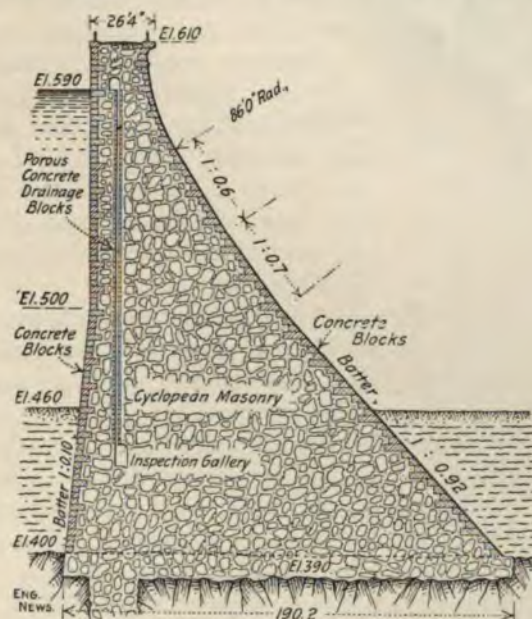
FIG. 224.—ASHOKAN DAM, MASONRY.

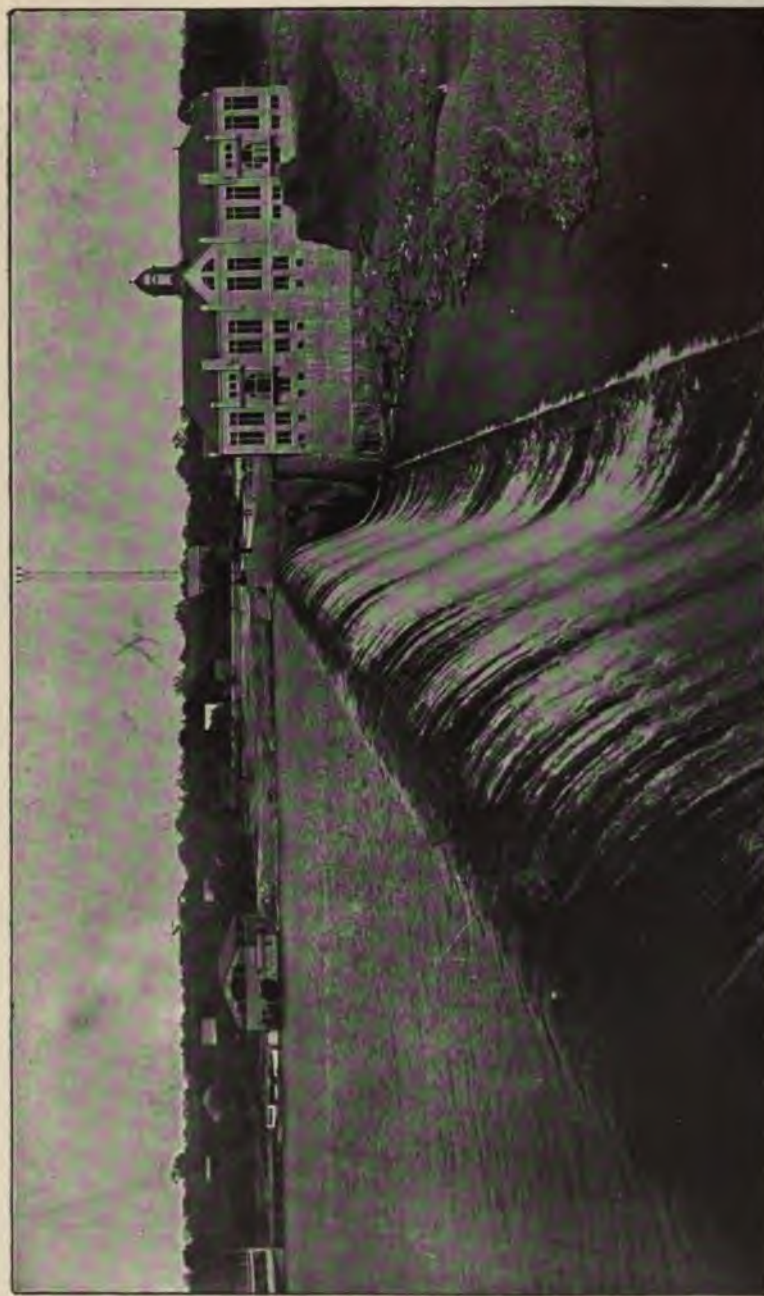
FIG. 228.—AUSTIN DAM AND POWER-HOUSE, TEXAS.

The Austin Dam, Texas.—The city of Austin, Texas, the capital of the State, with a population of about 25,000 inhabitants, has erected one of the most notable masonry dams of the United States, across the Colorado River, $2\frac{1}{4}$ miles above the city, for power-development purposes. The dam, Fig. 228, was built in 1891–92. It was designed by Mr. Jos. P. Frizzell, M. Am. Soc. C. E. of Boston, and about two-thirds completed by him. He was succeeded by Mr. J. T. Fanning. The dam proper is 1091 feet long between bulkheads and 68 feet high. It is vertical on the up-stream face, while the down-stream face is inclined at a batter of 3 in 8, terminating in a vertical curve of 31 feet radius, while the crest is rounded on a radius of 20 feet on lower side, forming an ogee curve that has the general shape of the trajectory of falling water.

The dam is straight in plan, and contains about 88,000 cubic yards of masonry, of which 70,000 yards are of rough rubble, made of the limestone quarried near the site, and 18,000 yards are of cut-stone range-work, in

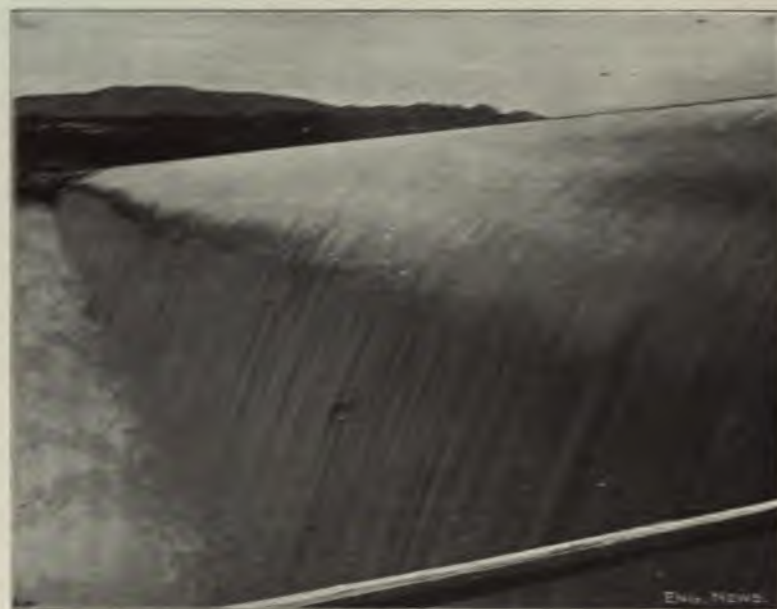
FIG. 229.—AUSTIN DAM DURING FLOOD OF APRIL 7, 1900, AND IMMEDIATELY BEFORE THE BREAK.

The appearance of the dam immediately before the break is shown in Fig. 229. Figs. 230 and 231 graphically present the break and the bodily movement of a section of the dam down-stream intact, better than any detailed description. The author is indebted to *Engineering News* for these three cuts.
